COAL CREEK SUPERFUND SITE

CHEHALIS, WASHINGTON

FIVE YEAR REVIEW REPORT

MARCH 2005

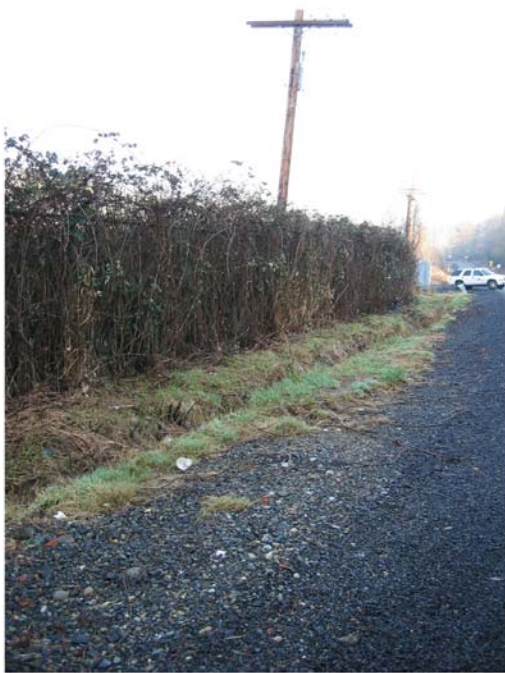
An 8 foot high chain link fence with a locked gate surrounds the containment cell and the adjacent property to the east and south. The fence appeared to be in good shape and both gates were locked. No signs of human intrusion onto the site were observed. There was some garbage inside the fence near the road that could have been thrown over the fence.

Photo 1 - Fence along Coal Creek Road

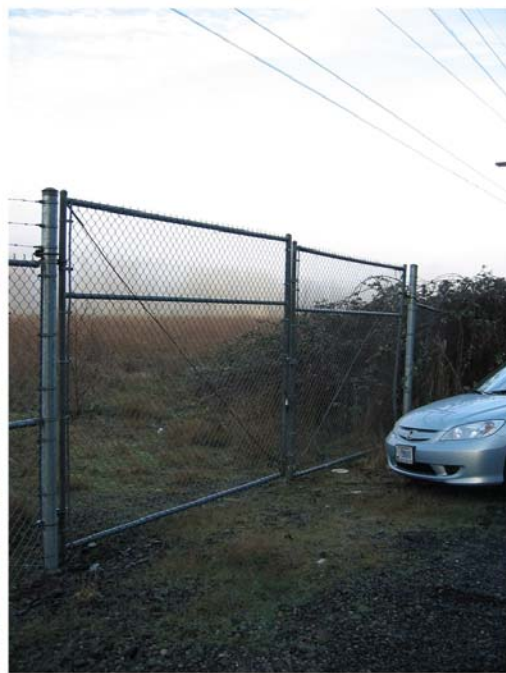
Photo 2 - Gate in fence along Coal Creek Road

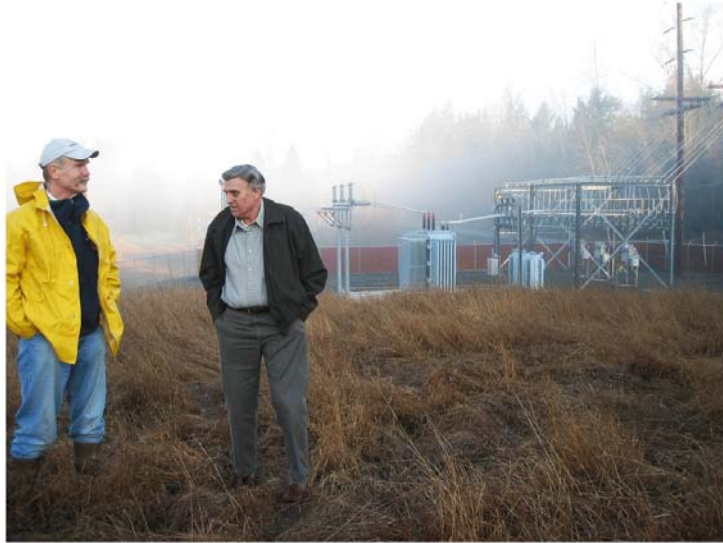
The landfill cell cover continues to support a good growth of grasses with no shrubs or trees. No erosion was observed along the slope of the containment cell and no obvious differential settlement was observed on the cell. It appears that the cap has not been mowed, which is consistent with the design of the cap and the O&M plan.

Photo 3 - Vegetation on top of cap, looking north

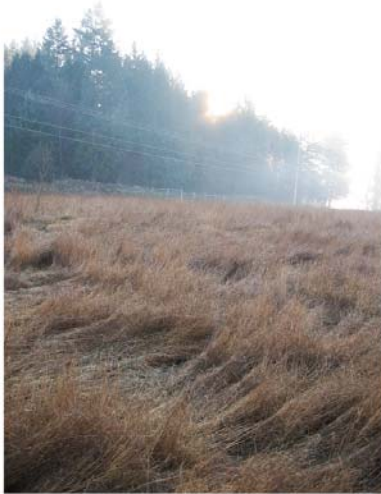
Photo 4 - Vegetation on cap looking southeast

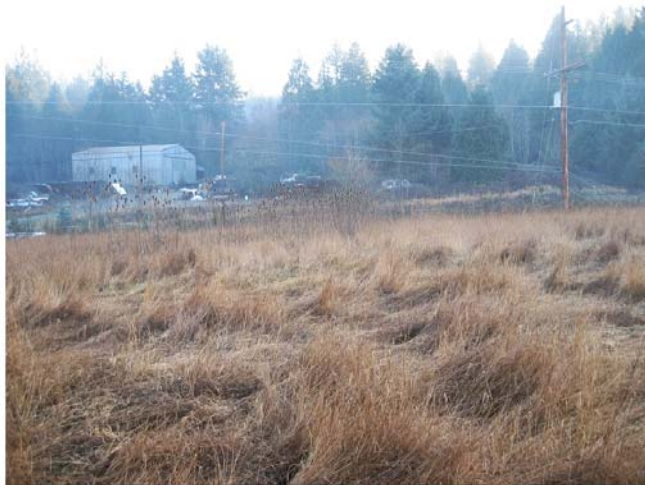
Photo 5 - Vegetation on cap looking east

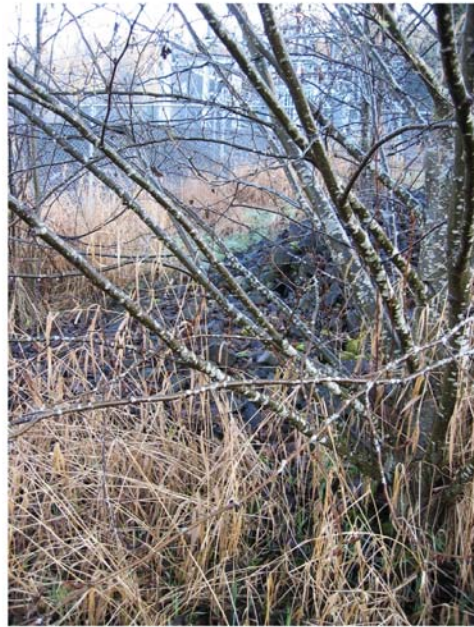
There are two types of drains at the edge of the cell: surface water interceptor trench discharge drains and diversion drains. Two surface water interceptor trenches were constructed to collect surface and shallow ground water from the up gradient side of the site. Trees are growing near the riprap below the outlet of the northwest interceptor trench and may need to be monitored to ensure that the outlet is not blocked. No potential problems were noted at the

Photo 6 - Northwest interceptor trench drain

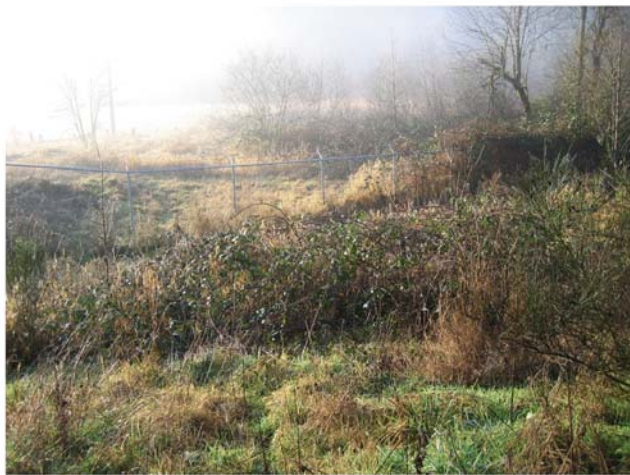
outlet of the southern interceptor trench. In addition, there are approximately 13 diversion drain outlets that connect to the drainage layer in the cap. Three of these were spotted during the site visit and they appeared to be in good condition.

Photo 7 - Vegetation near southern interceptor trench drain

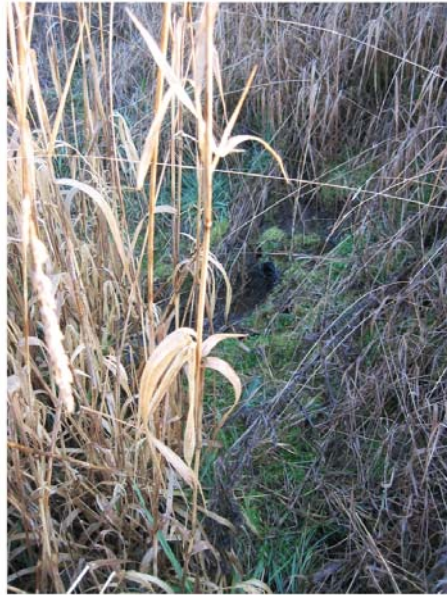
Photo 8 - Diversion drain outlet

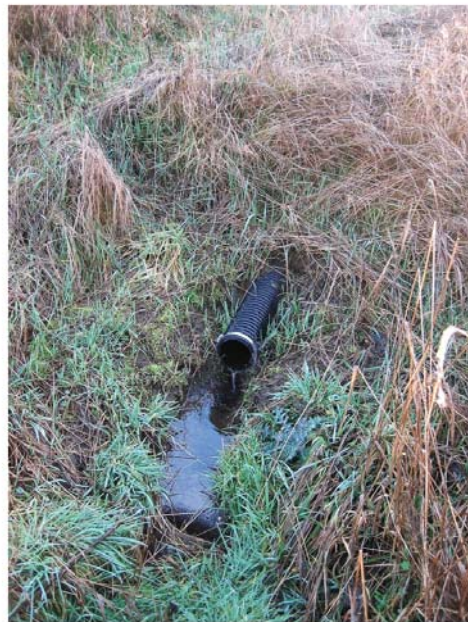
Photo 9 - Diversion drain outlet
